CV-clutch

Criteria:

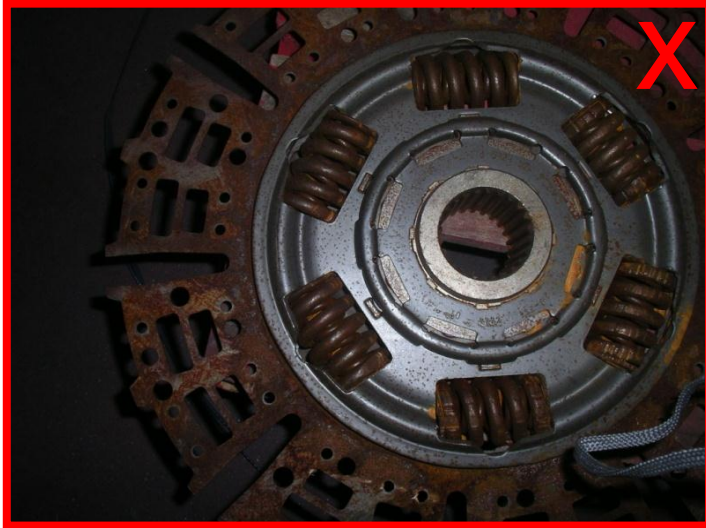
missing lining

Clutch disc is dismantled
→ not acceptable

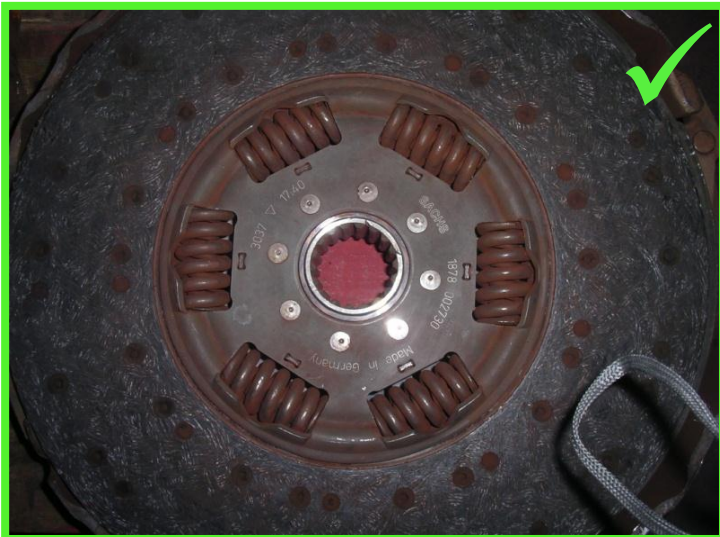
Clutch disc is complete, lining is present
→ acceptable

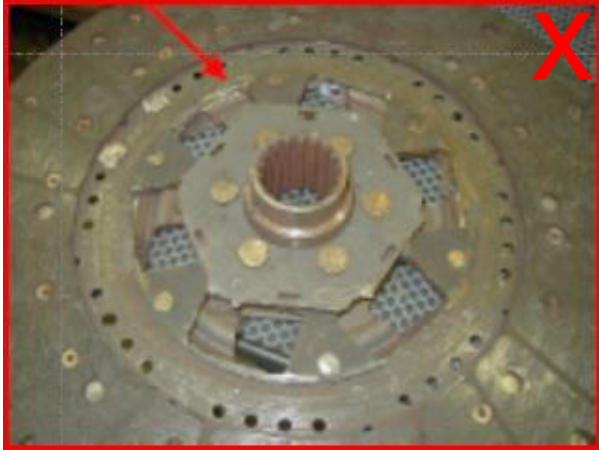
Broken disc and missing springs
→ not acceptable

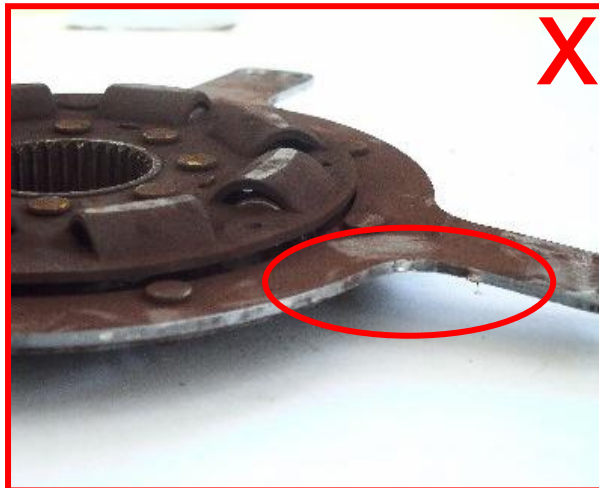
Torsional vibration absorber cracked or deformed
→ not acceptable

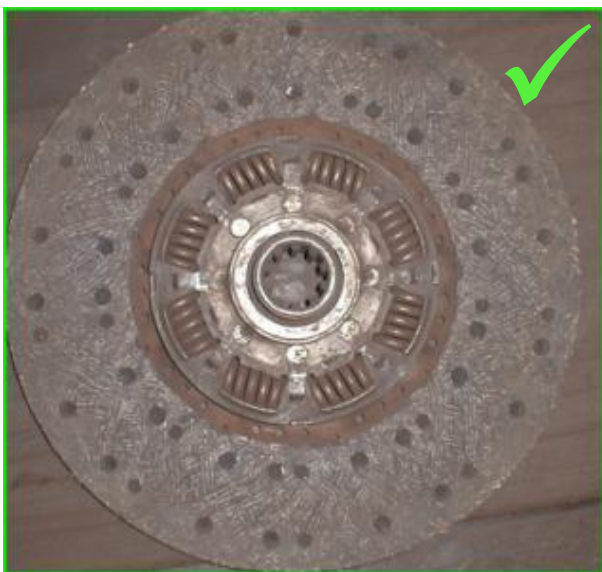
Clutch disc is complete when containing all springs.
→ acceptable

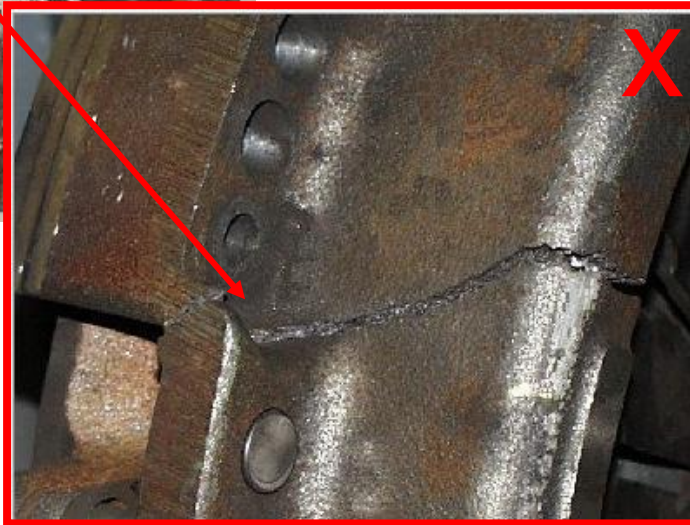
Housing (steel sheet make housing)
complete
→ acceptable

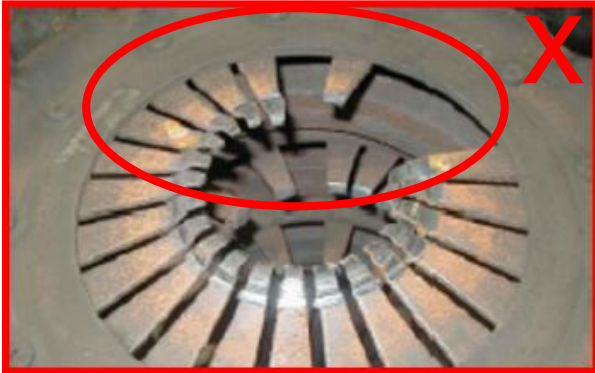
Missing/broken fingers of the diaphragm spring
→ not acceptable

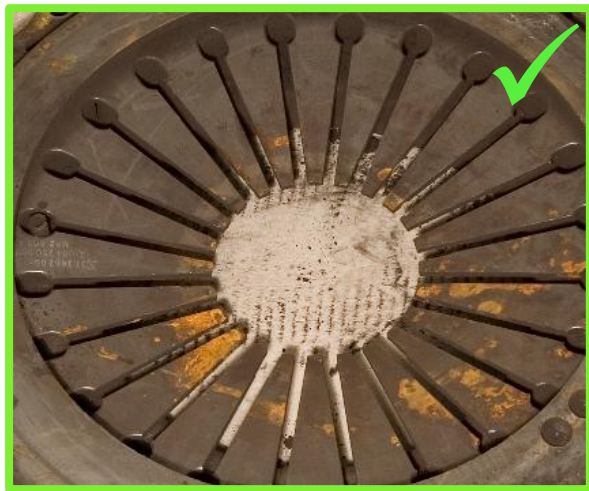
Slight weariness of the fingertips of the diaphragm spring → acceptable

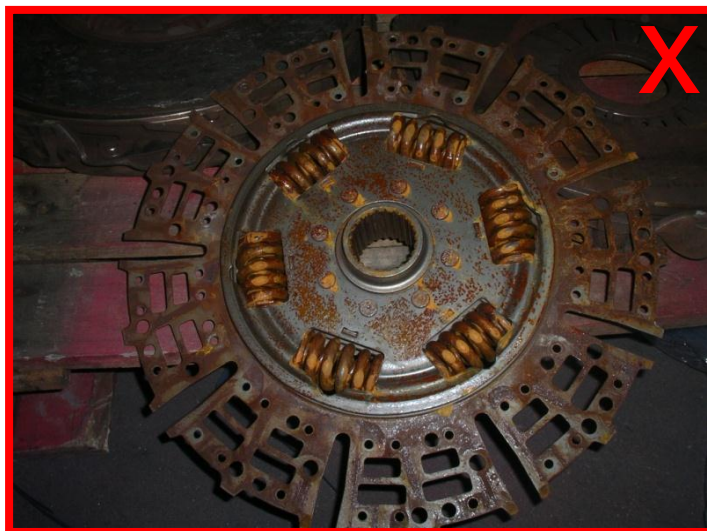
Surface corrosion is acceptable, but not pitting corrosion
